Debris/Ice/TPS Assessment and Integrated Photographic Analysis of Shuttle Mission STS-64

**DEBRIS/ICE/TPS ASSESSMENT
AND
INTEGRATED PHOTOGRAPHIC ANALYSIS
OF
SHUTTLE MISSION STS-64**

9 August 1994

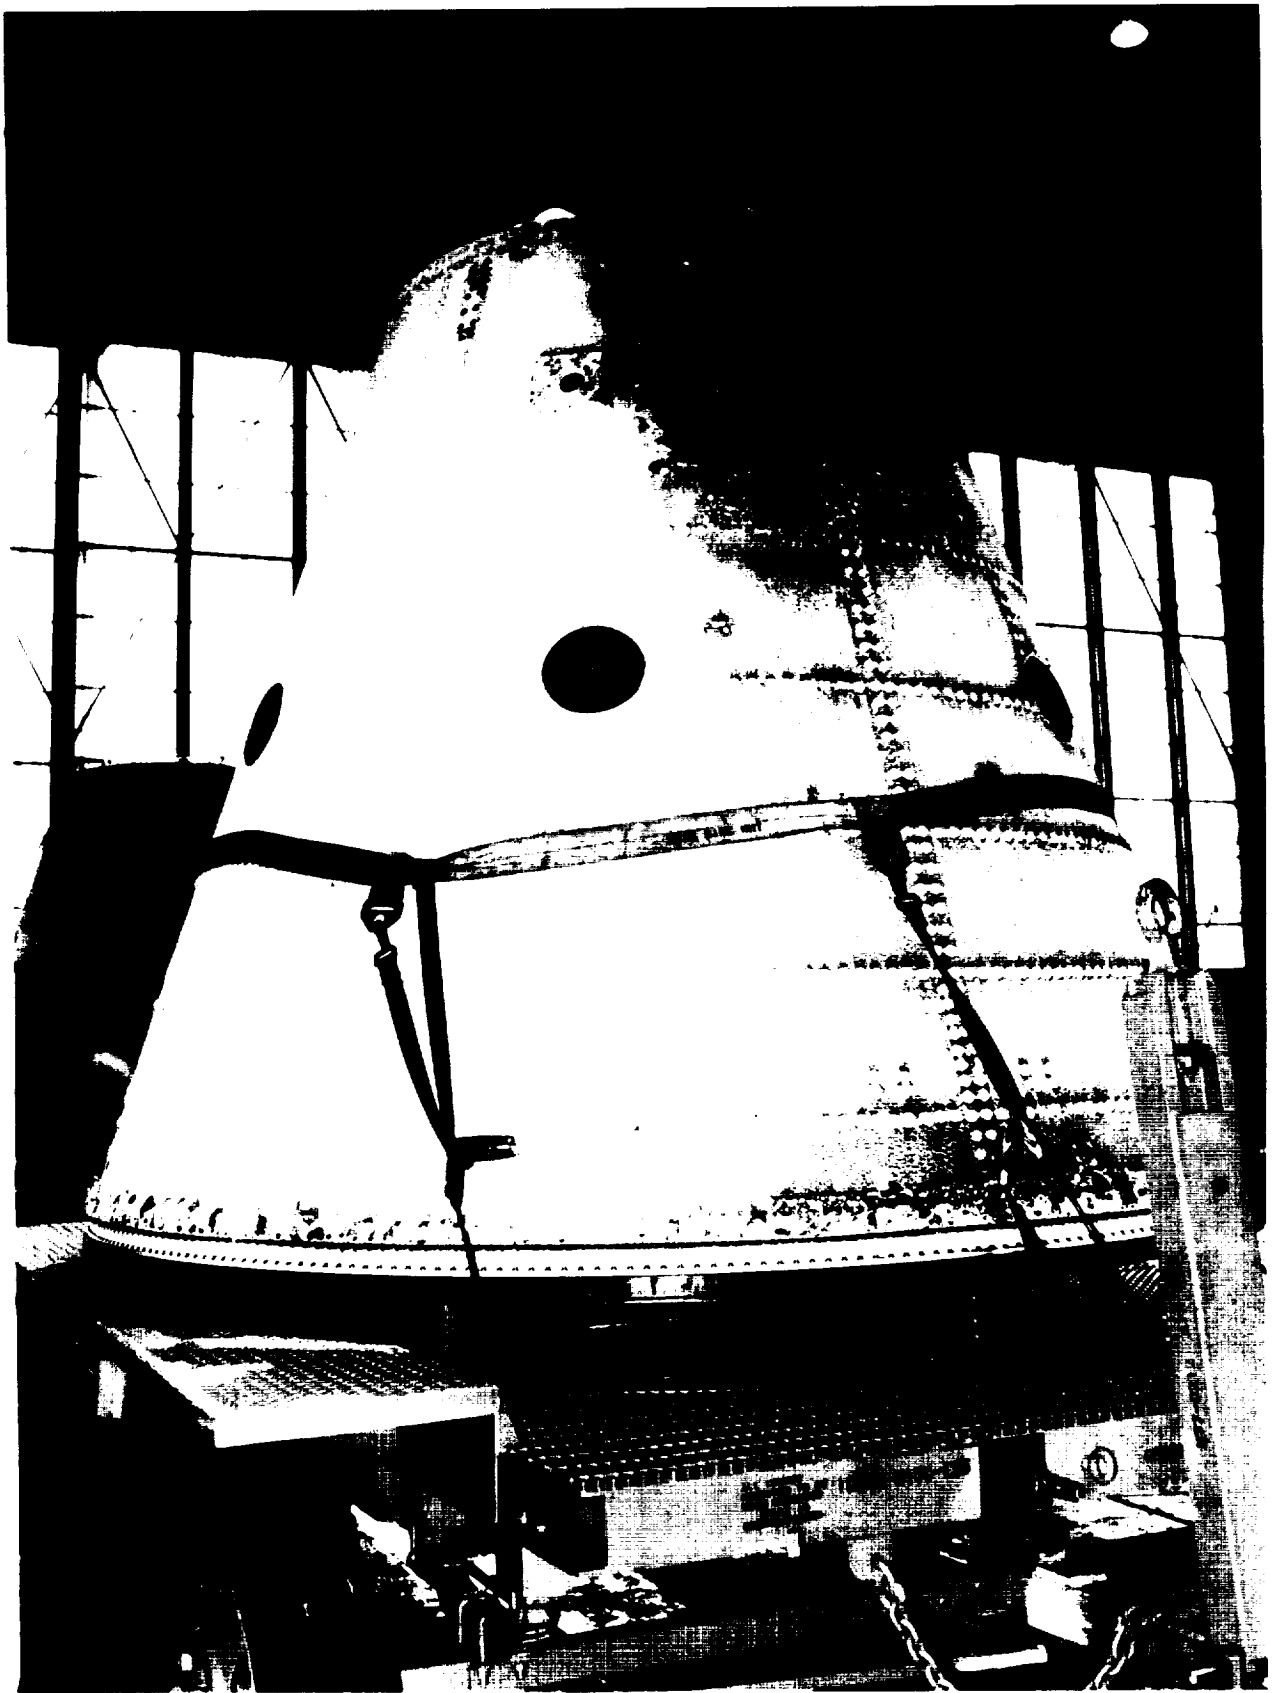
Photo 14 : LH SRB Frustum

The LH frustum was missing no TPS but had 18 MSA-2 debonds over fasteners (Figure 2). Hypalon paint was blistered/missing where BTA closeouts had been applied. Some of the underlying BTA was lightly sooted. All BSM aero heat shield covers had locked properly in the fully opened position.

The LH frustum was missing no TPS but had 18 MSA-2 debonds over fasteners. Hypalon paint was blistered/missing where BTA closeouts had been applied. All BSM aero heat shield covers had locked in the fully opened position.

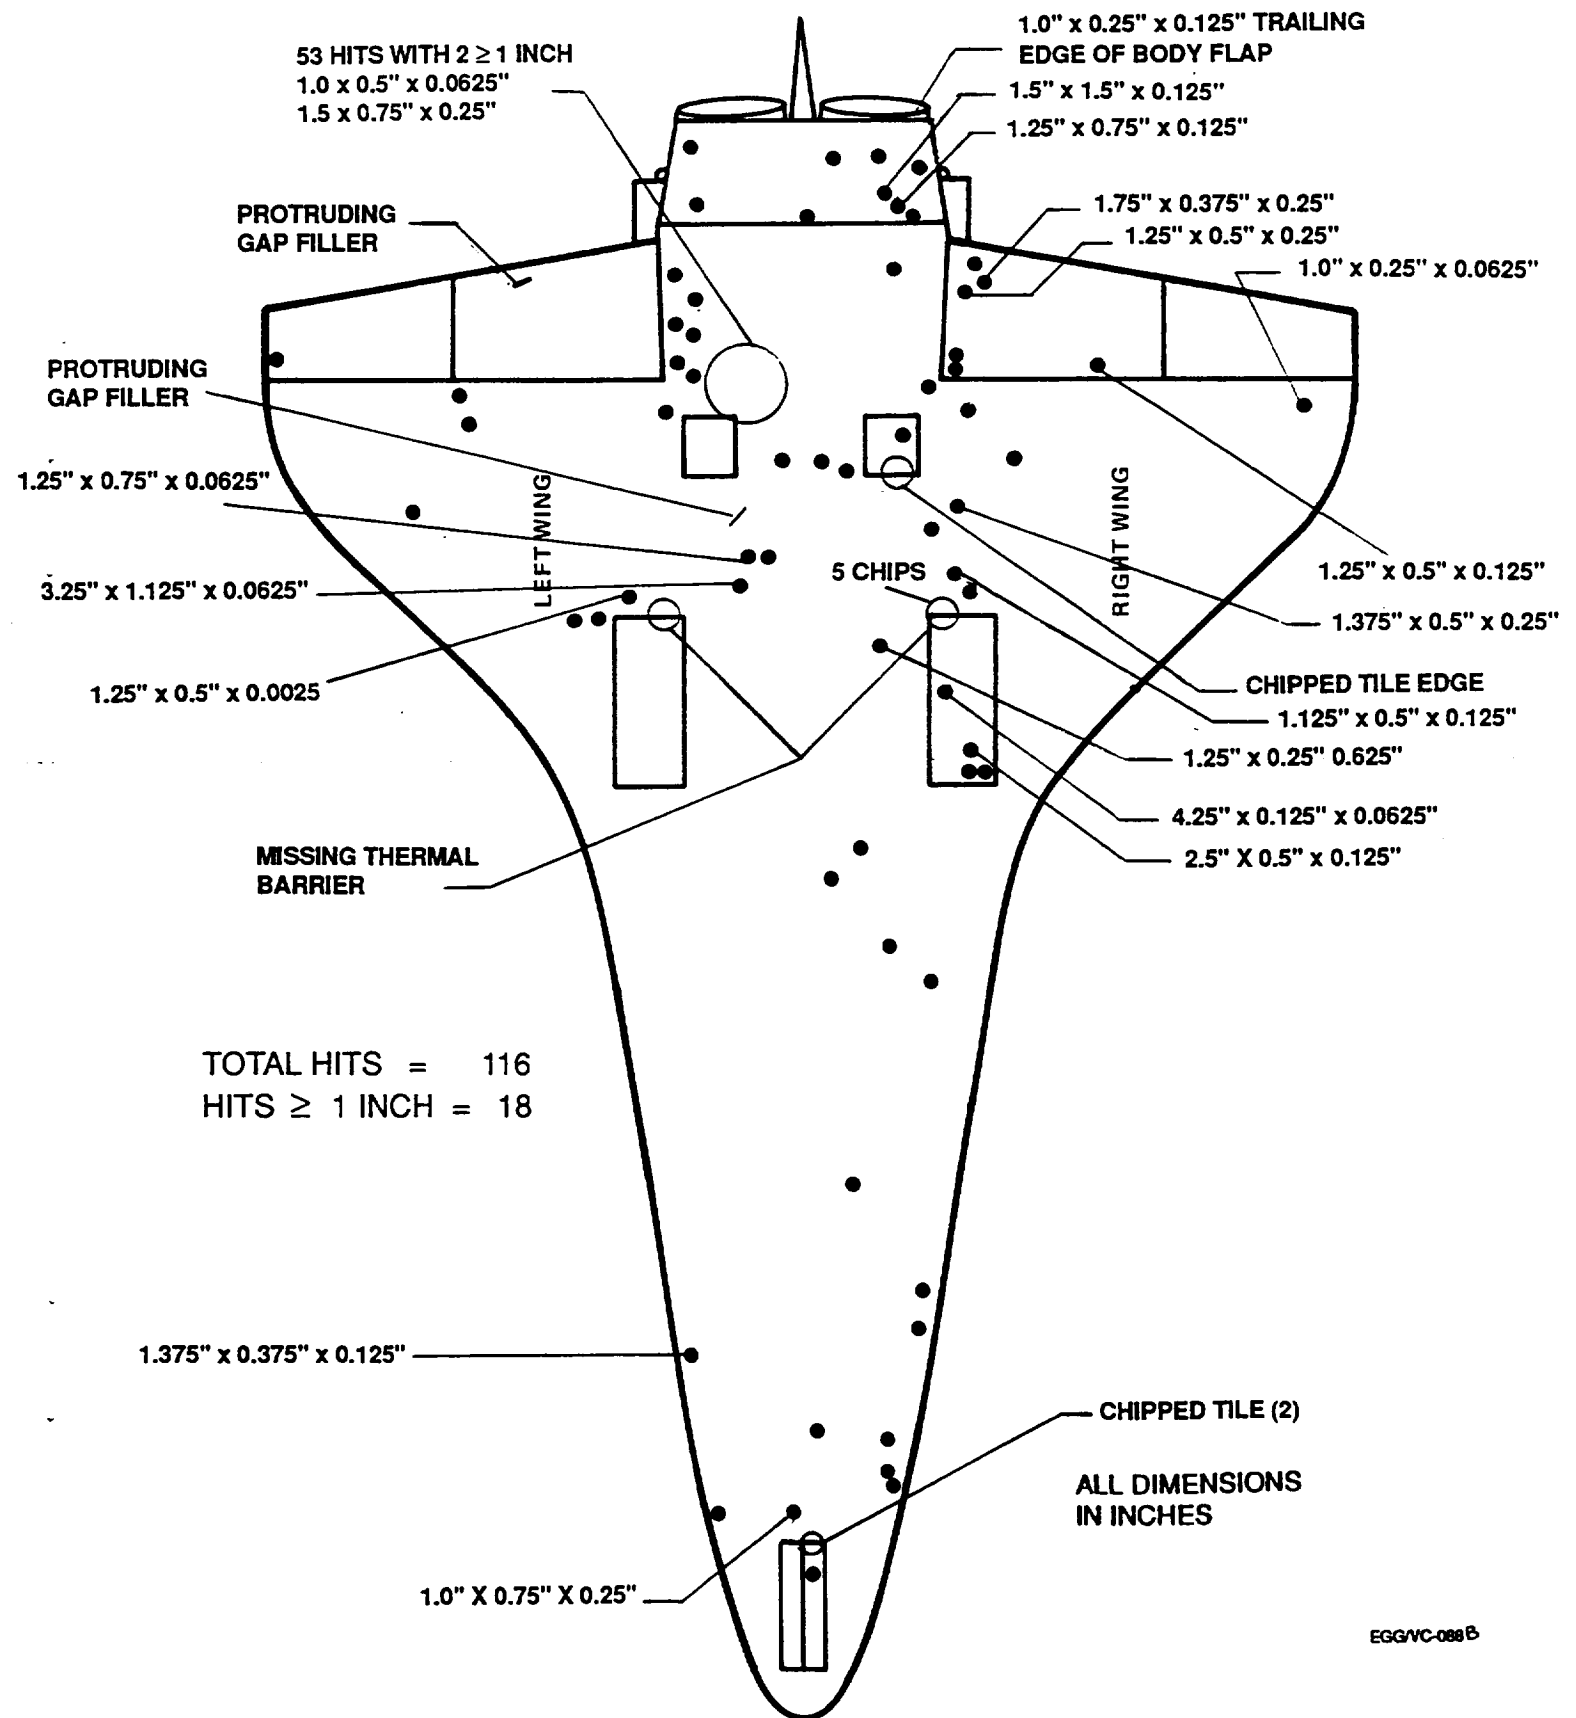
Figure 3 : Orbiter Lower Surface Debris Map

The Orbiter lower surface sustained a total of 116 hits, of which 18 had a major dimension of 1-inch or greater. A total of 53 hits occurred just aft of the LH2 ET/ORB umbilical. Two of these damage sites had a major dimension greater than 1-inch. Cluster of hits aft of the LH2 and LO2 ET/ORB umbilicals are believed to be impacts from umbilical ice and purge barrier (baggie) material.
